UNITED STATES ENVIRONMENTAL PROTECTION AGENCY

INSTALLATION NAME: Arcelor Mittal Burns Harbor, LLC

DATE OF RCRA INSPECTION: June 13, 14, 15, 20, 27 - 30, 2011

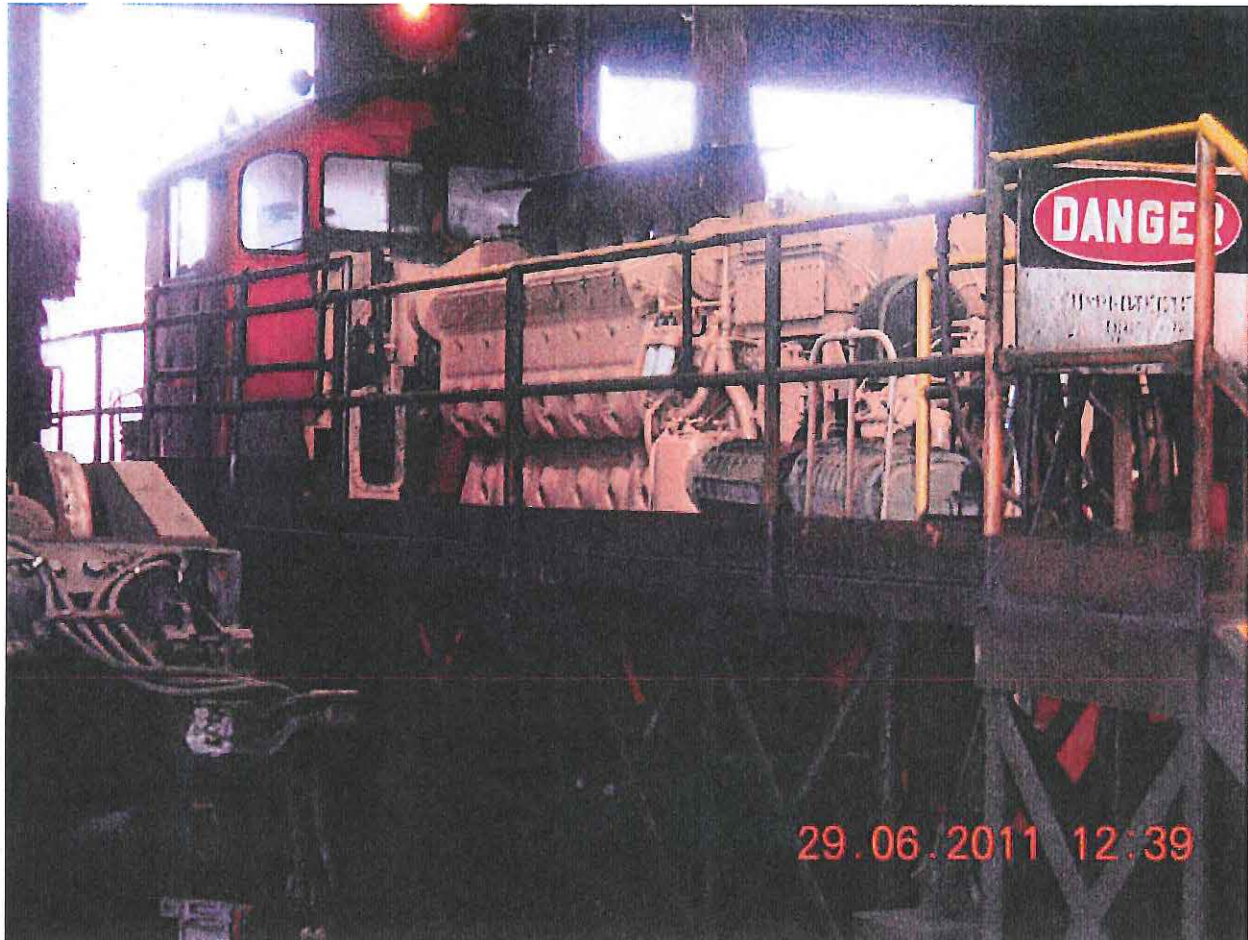
Facility: Arcelor Mittal, IND003913423
Location: 250 West US Highway 12, Burns Harbor, Indiana
Date: June 29, 2011, 12:39 p.m.
Photographer: Robert Dean Smith, LPG
Camera: Nikon Coolpix, 12.0 megapixels
Description: Photograph 79: Diesel electric engine undergoing maintenance in the maintenance shop. Facing NE.

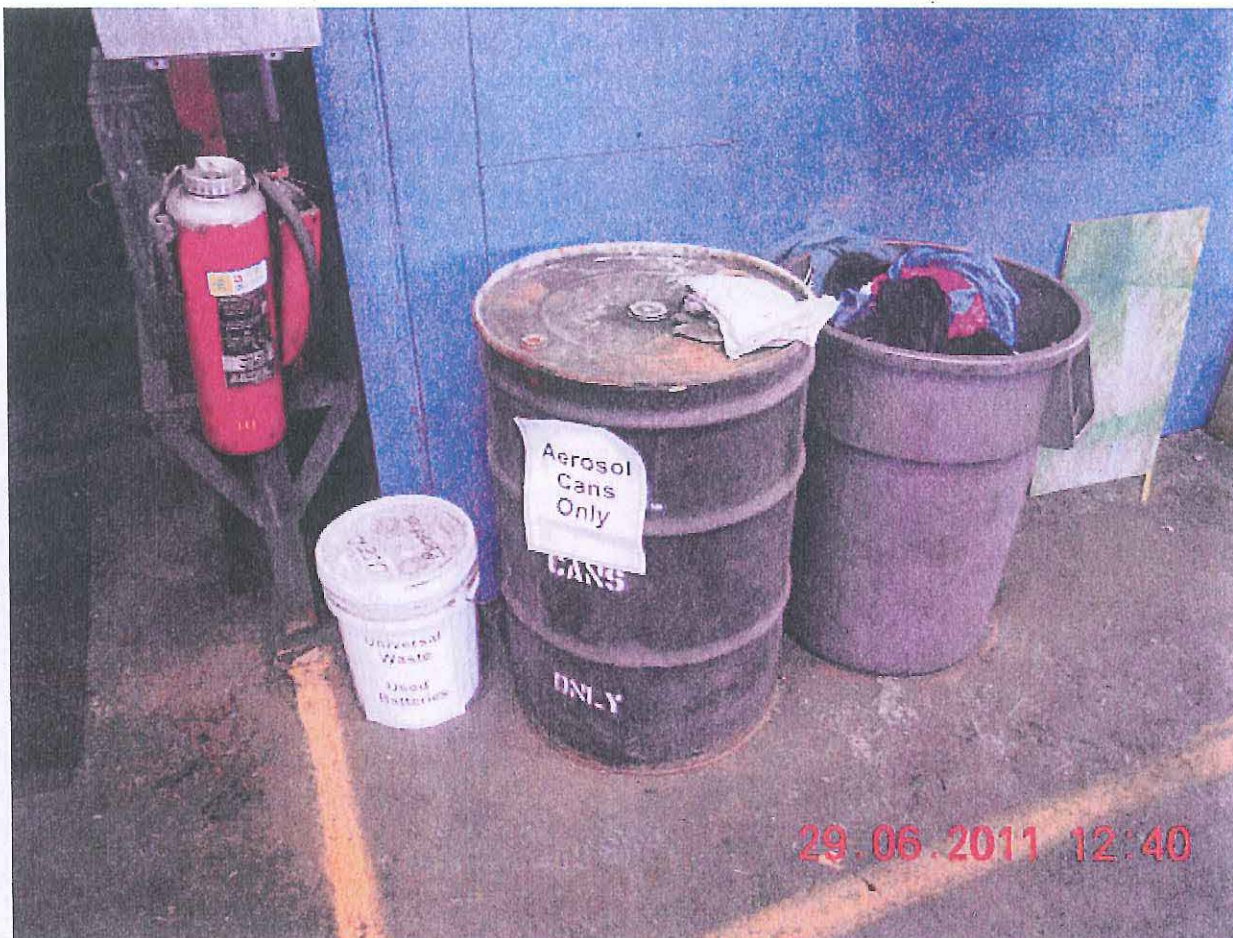
- Inspector Smith observed and photographed a parts washer (photograph 78).
- Inspector Smith observed and photographed a diesel-electric locomotive undergoing maintenance (photograph 79).
- Inspector Smith observed and photographed a 55-gallon drum that contained aerosol cans in satellite accumulation. Adjacent to the aerosol cans drum was an open garbage can with unused, fresh rags and a 5-gallon bucket with a label

"universal waste used batteries". The 5-gallon bucket was stored closed (photograph 80).

Facility: Arcelor Mittal, IND003913423
Location: 250 West US Highway 12, Burns Harbor, Indiana
Date: June 29, 2011, 12:40 p.m.
Photographer: Robert Dean Smith, LPG
Camera: Nikon Coolpix, 12.0 megapixels
Description: Photograph 80: Aerosol cans, satellite accumulation area, maintenance shop. On the left is a 5 gallon bucket of universal waste container holding used batteries. A container of fresh rags is on the right.

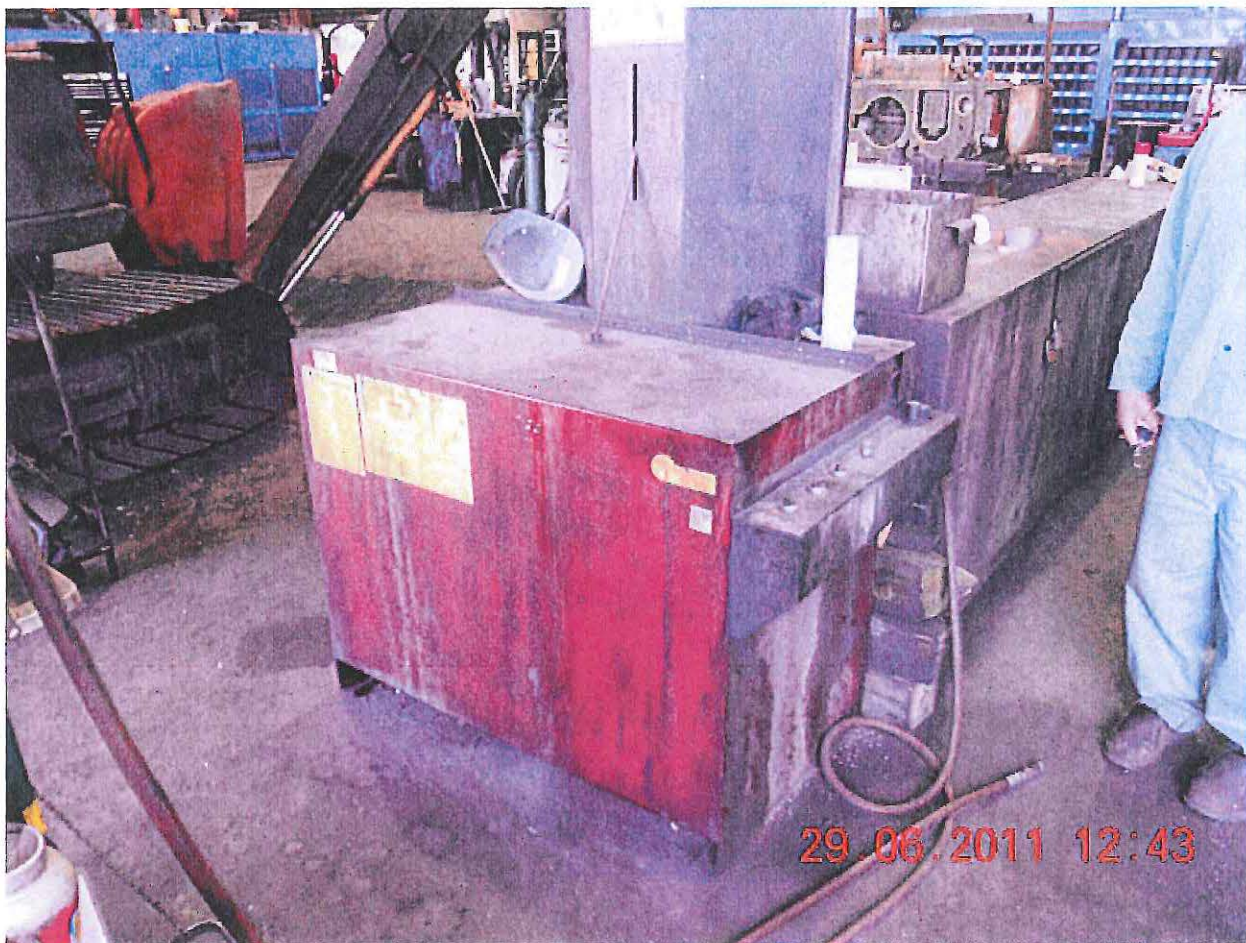
Facility: Arcelor Mittal, IND003913423
Location: 250 West US Highway 12, Burns Harbor, Indiana
Date: June 29, 2011, 12:43 p.m.
Photographer: Robert Dean Smith, LPG
Camera: Nikon Coolpix, 12.0 megapixels
Description: Photograph 81: Parts washer, maintenance shop. Facing NE.

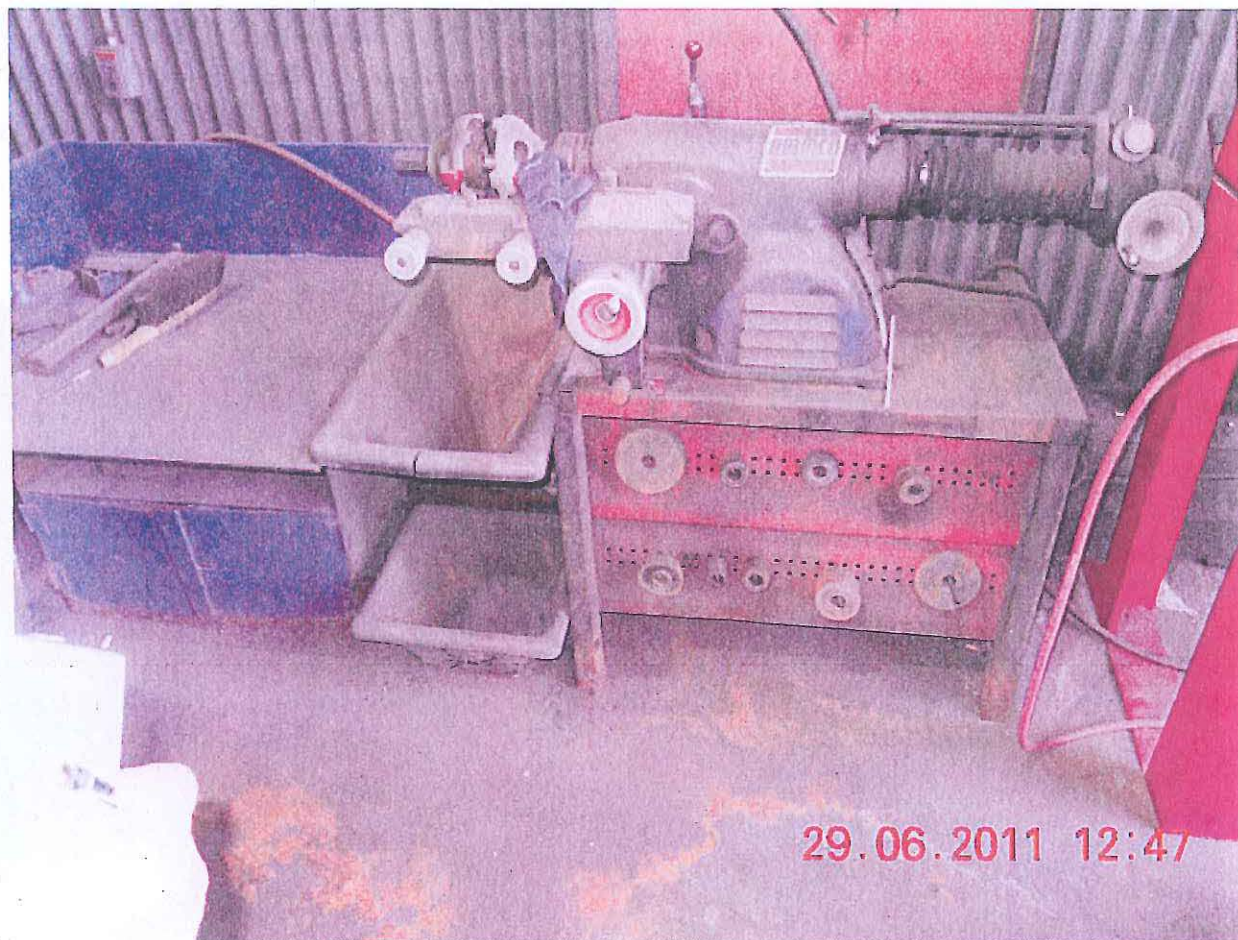
- Inspector Smith observed and photographed a second parts washer in the maintenance shop (photograph 81).
- Inspector Smith observed and photographed a grinding wheel with an open container of grinder waste. The grindings have not been characterized for hazardous waste (photograph 82).
- Inspector Smith observed and photographed a bead blast box and a 15 gallon drum which extracts dust from the box via vacuum (Photograph 83).

Facility: Arcelor Mittal, IND003913423
Location: 250 West US Highway 12, Burns Harbor, Indiana
Date: June 29, 2011, 12:47 p.m.
Photographer: Robert Dean Smith, LPG
Camera: Nikon Coolpix, 12.0 megapixels
Description: Photograph 82: grinding wheel, maintenance shop. The grinding dust has not been characterized for hazardous constituents.

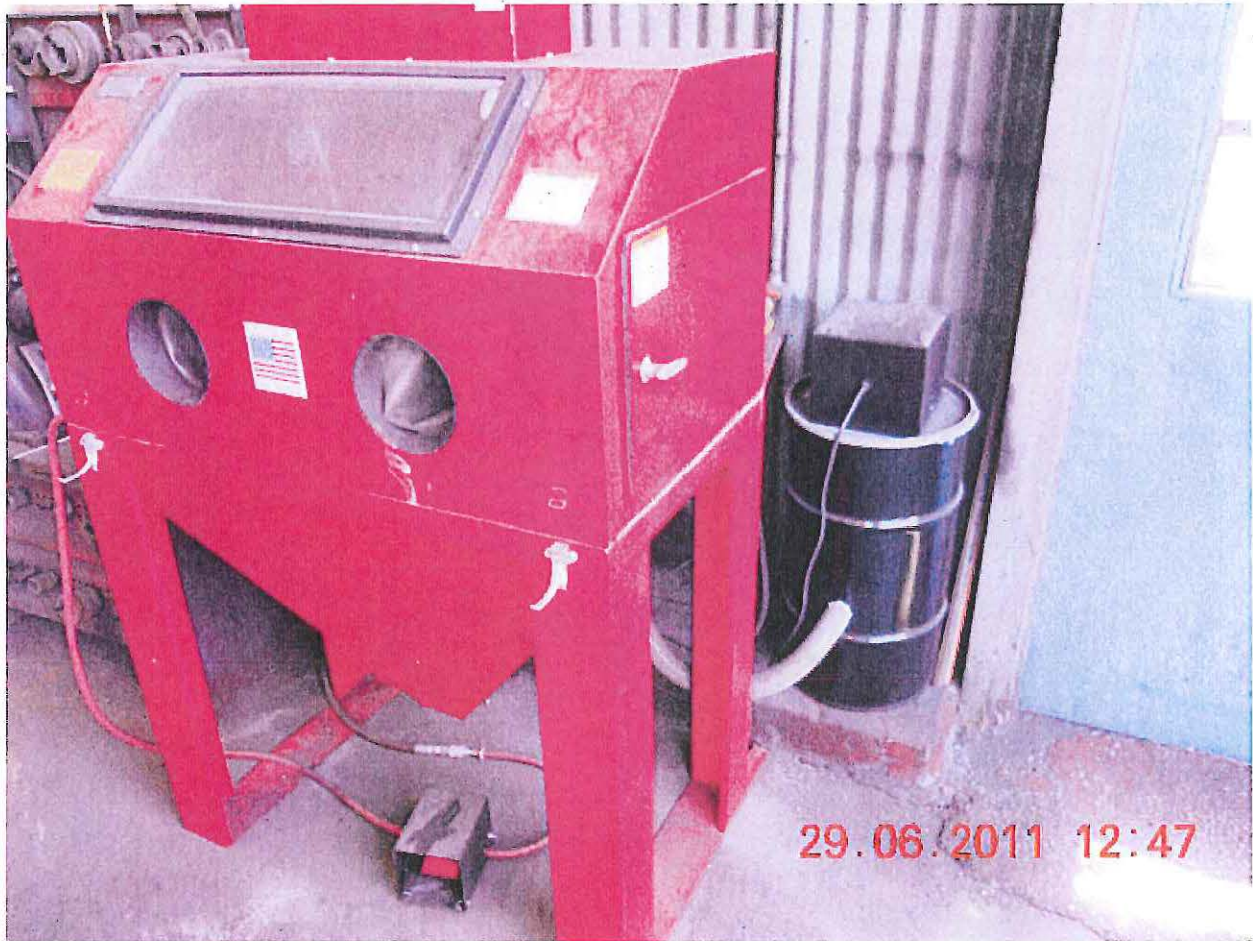
Facility: Arcelor Mittal, IND003913423
Location: 250 West US Highway 12, Burns Harbor, Indiana
Date: June 29, 2011, 12:47 a.m.
Photographer: Robert Dean Smith, LPG
Camera: Nikon Coolpix, 12.0 megapixels
Description: Photograph 83: Bead blasting box, maintenance shop. Facing S.

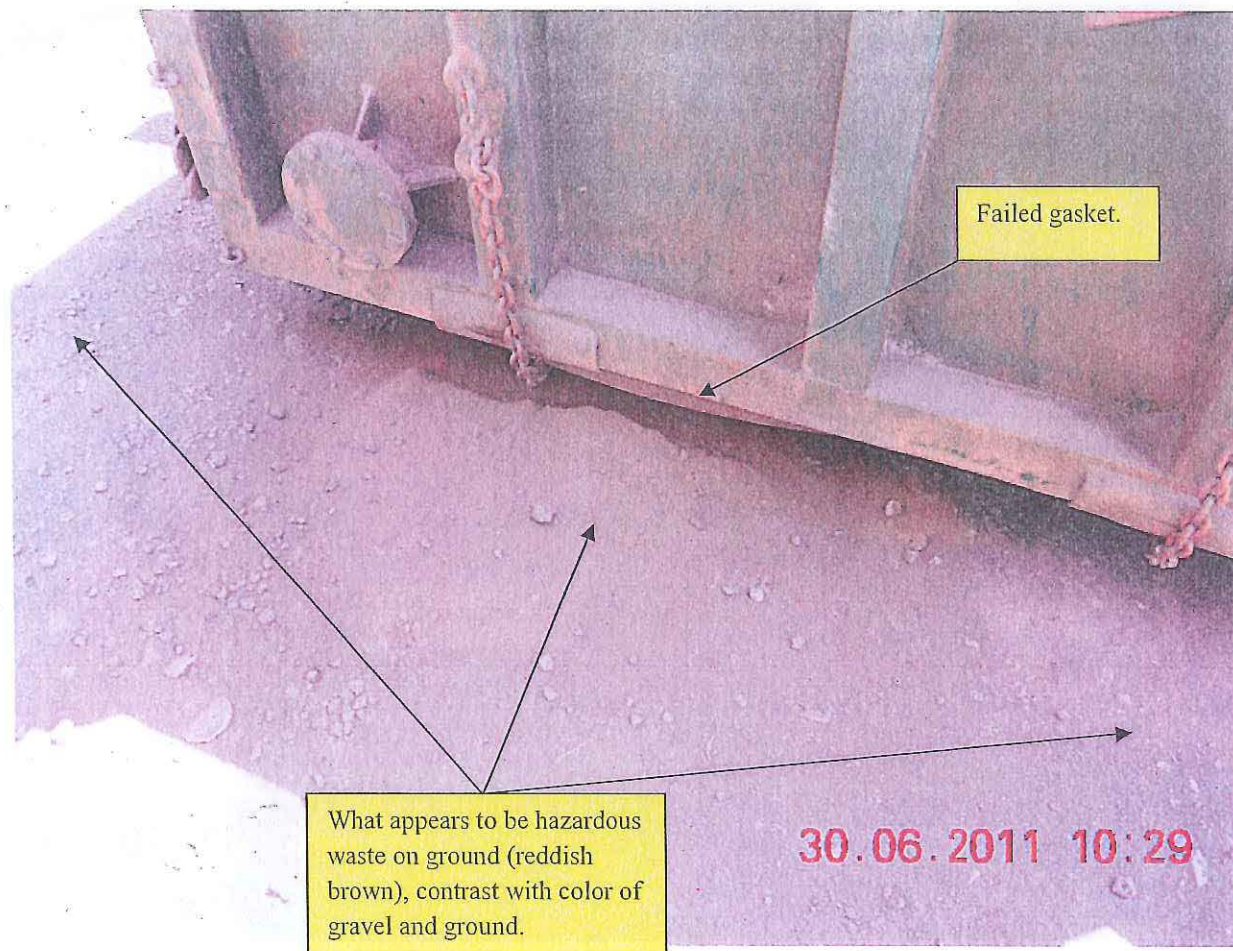
- Inspector Smith observed and photographed a small, linear pile of suspected hazardous waste dust that was released from a vacuum roll-off box that was placed near the baghouses associated with the LTS. The photograph shows that the gasket was blown out and that the roll off box was not sealed. The dust was reddish-brown and contrasted the grey color of the dust that seemed to normally cover the area (Photograph 84).

Facility: Arcelor Mittal, IND003913423
Location: 250 West US Highway 12, Burns Harbor, Indiana
Date: June 30, 2011, 10:29 a.m.
Photographer: Robert Dean Smith, LPG
Camera: Nikon Coolpix, 12.0 megapixels
Description: Photograph 84: Hazardous waste dust released from vacuum roll off box, LTS shop. The gasket for the roll off box can be seen just below the bottom edge of the horizontal beam of the roll off box. This vacuum roll-off box is located in the furnace area of the plant. This area is 30 degrees off of "plant north". The orientation is rotated 30 degrees to the west. Plant north is close to true north. The orientation of the vacuum roll-off box is close to NE-SW. Facing N.

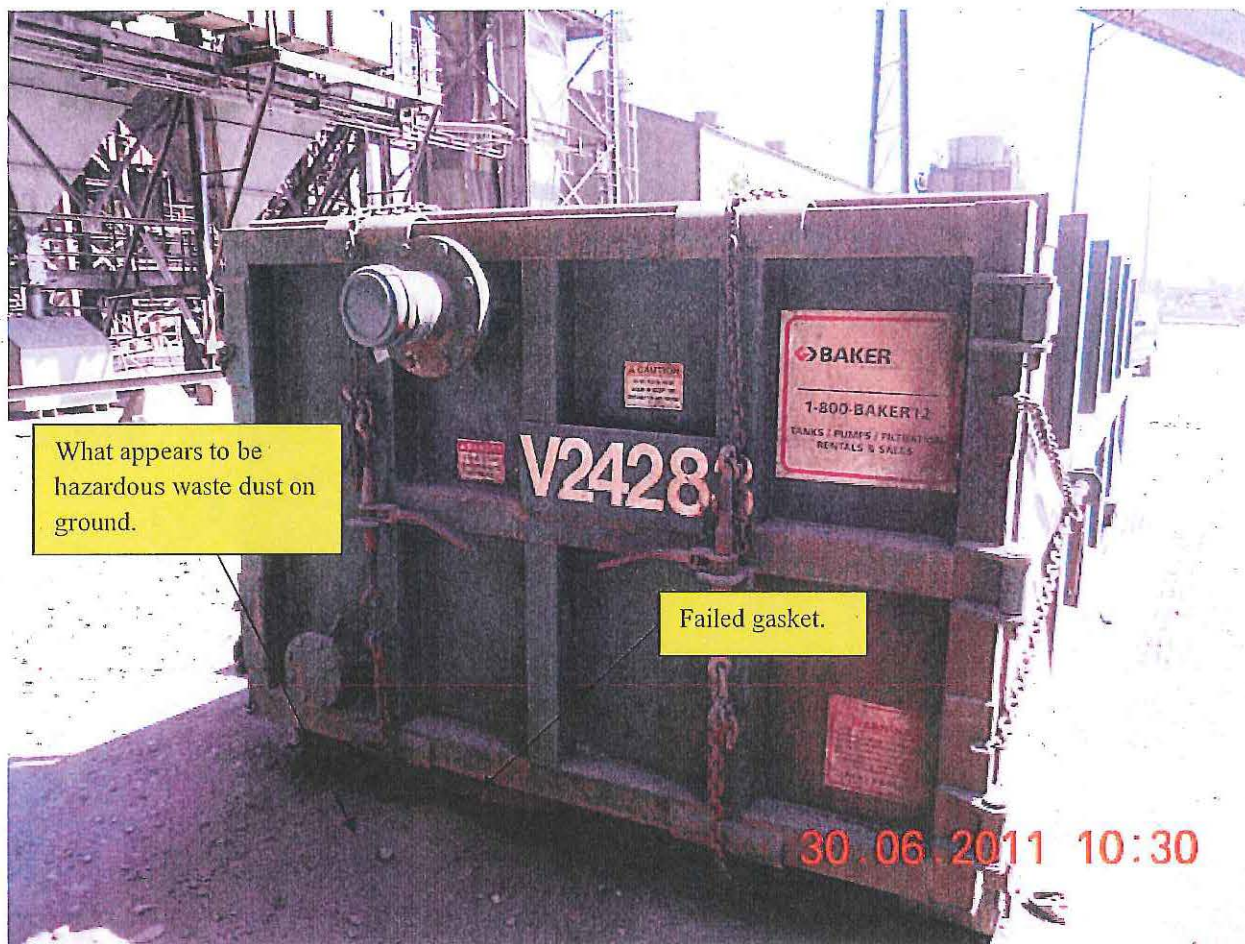
- Inspector Smith observed and photographed that the roll-off box had the serial number V24283. The release of the suspected hazardous waste is seen at the bottom of the roll off box (photograph 85).

Description: **Photograph 85:** Roll off box that released hazardous waste at the LTS shop. This is the opposite end of the release, showing the serial number of the box. This vacuum roll-off box is located in the furnace area of the plant. This area is 30 degrees off of "plant north". The orientation is rotated 30 degrees to the west. Plant north is close to true north. The orientation of the vacuum roll-off box is close to NE-SW Facing N.

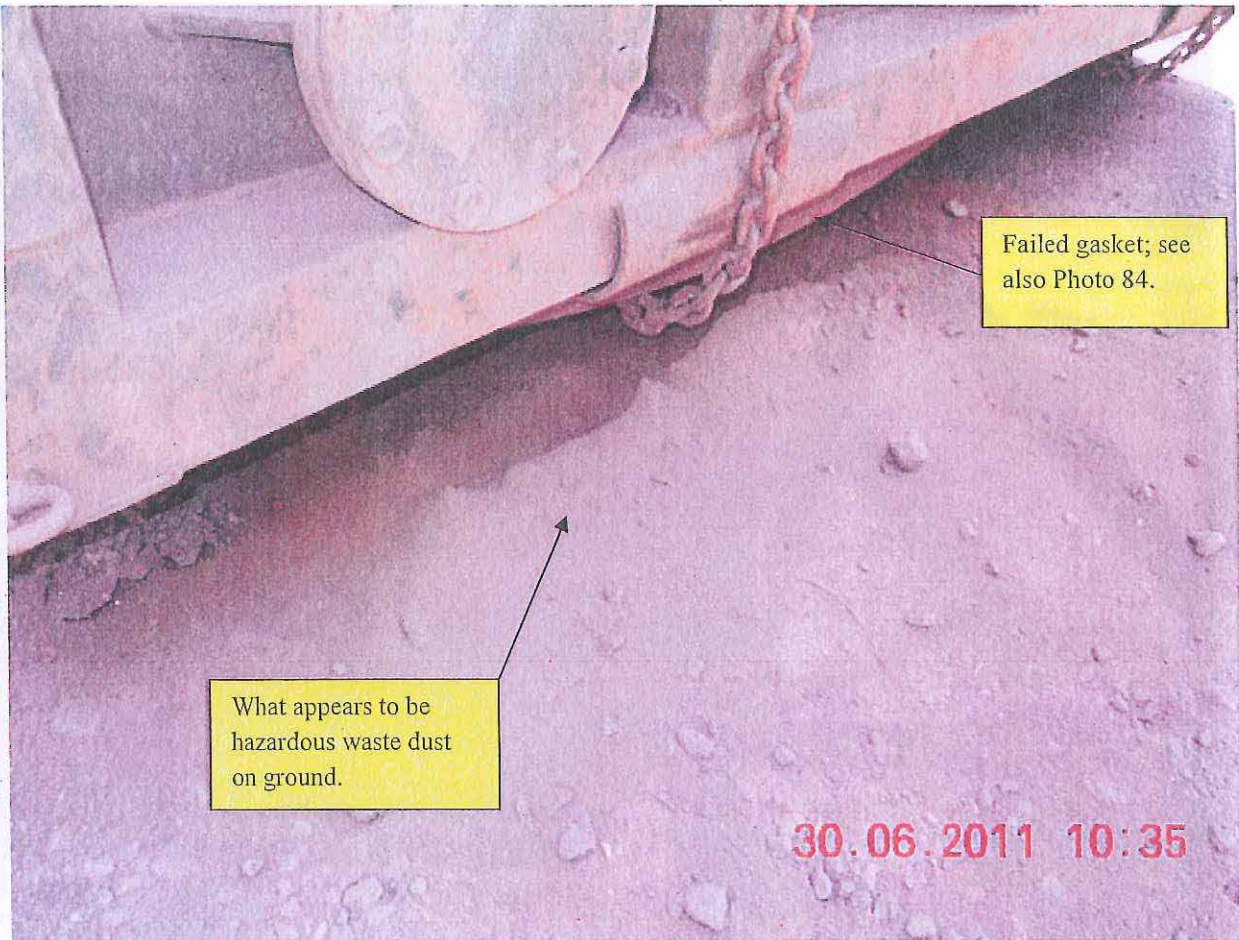
- Inspector Smith observed and photographed the release of the suspected hazardous waste close up (photograph 86).
- Inspector Smith observed and photographed the suspected hazardous waste dust box number 5 for the LTS. The photograph shows that there is no reddish brown dust at, under or near the dust box. The dust boxes are the origin of the dust that is placed into the roll-off box via vacuum (photograph 87).

Facility: Arcelor Mittal, IND003913423
Location: 250 West US Highway 12, Burns Harbor, Indiana
Date: June 30, 2011, 10:35 a.m.
Photographer: Robert Dean Smith, LPG
Camera: Nikon Coolpix, 12.0 megapixels
Description: Photograph 86: Hazardous waste LTS baghouse dust released from the vacuum roll off box. The blown gasket can be seen under the chain. This vacuum roll-off box is located in the furnace area of the plant. This area is 30 degrees off of "plant north". The orientation is rotated 30 degrees to the west. Plant north is close to true north . The orientation of the vacuum roll-off box is close to NE-SW. Facing N/NE.

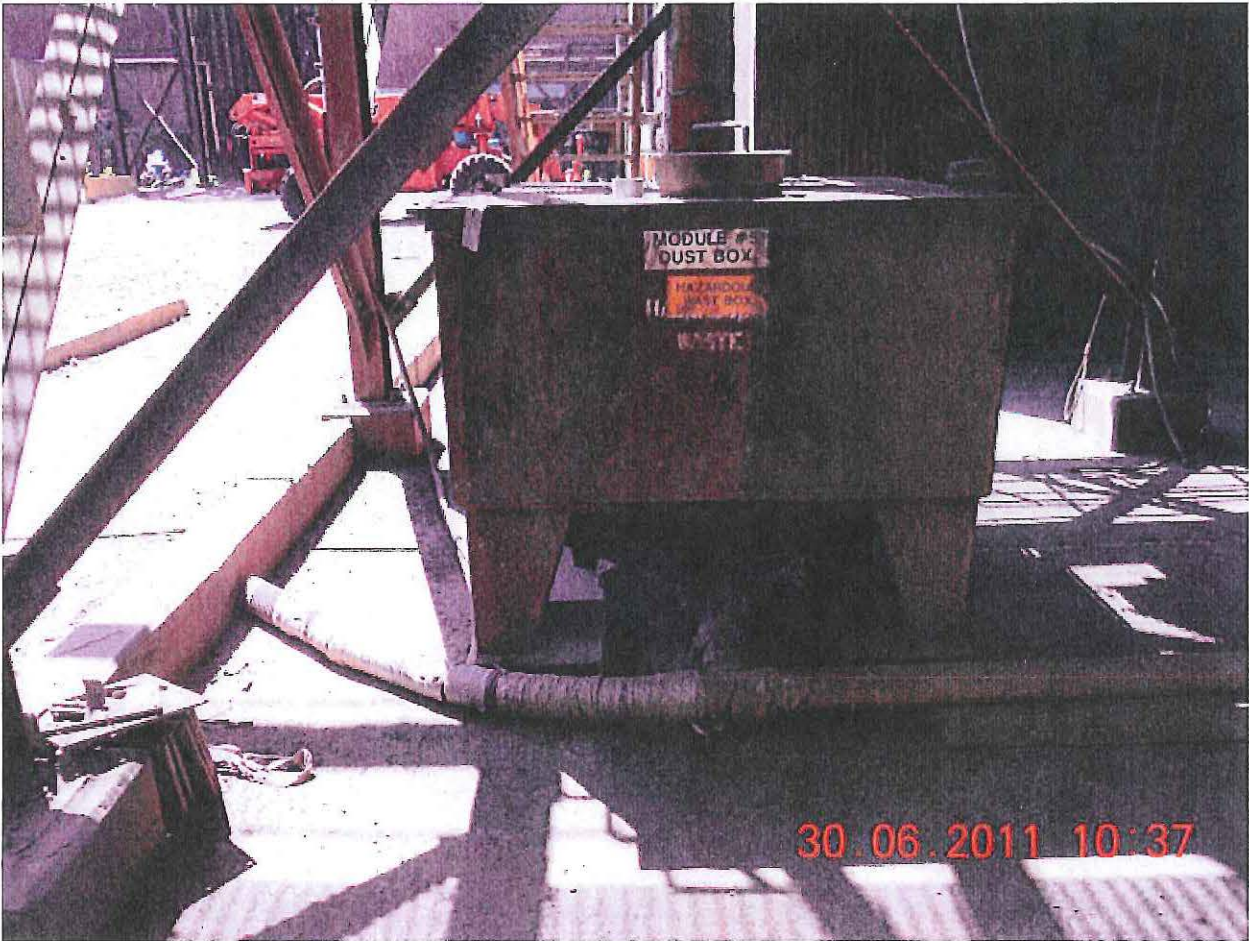
Facility: Arcelor Mittal, IND003913423
Location: 250 West US Highway 12, Burns Harbor, Indiana
Date: June 30, 2011, 10:37 a.m.
Photographer: Robert Dean Smith, LPG
Camera: Nikon Coolpix, 12.0 megapixels
Description: Photograph 87: Hazardous waste dust box at LTS.

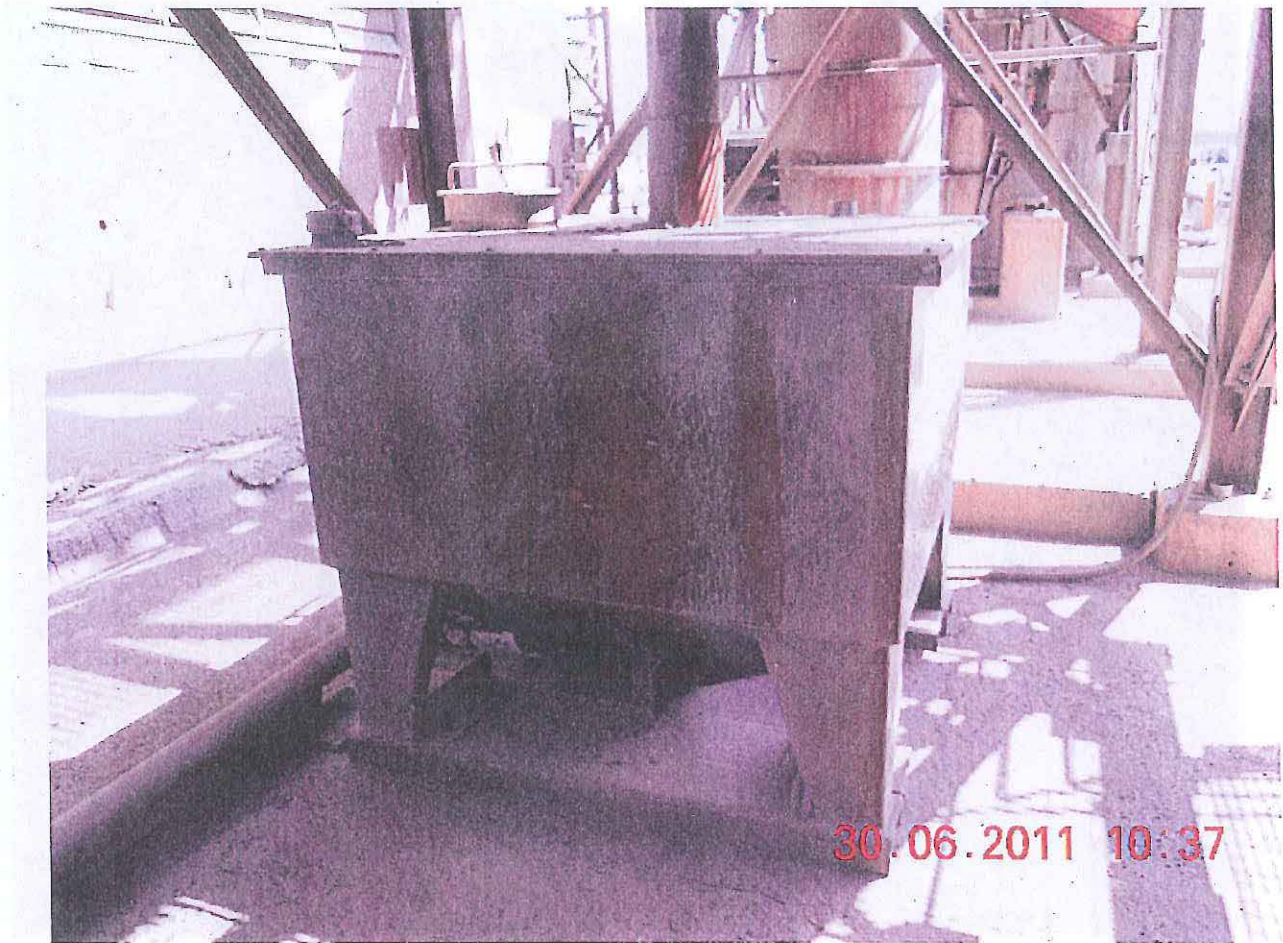
- Inspector Smith observed and photographed another dust box at the LTS and noted there was no reddish brown dust at or near the box (photograph 88).
- Inspector Smith observed and photographed dust in the secondary containment located under a dust box labeled "Module #5". I moved the dust with my foot to determine if the dust was reddish brown. The dust appeared to be grayish on the surface but it could not be determined if the dust was potentially the hazardous waste dust that accumulates in the dust box (photograph 89).

Facility: Arcelor Mittal, IND003913423
Location: 250 West US Highway 12, Burns Harbor, Indiana
Date: June 30, 2011, 10:37 a.m.
Photographer: Robert Dean Smith, LPG
Camera: Nikon Coolpix, 12.0 megapixels
Description: Photograph 88: Dust hopper at LTS.

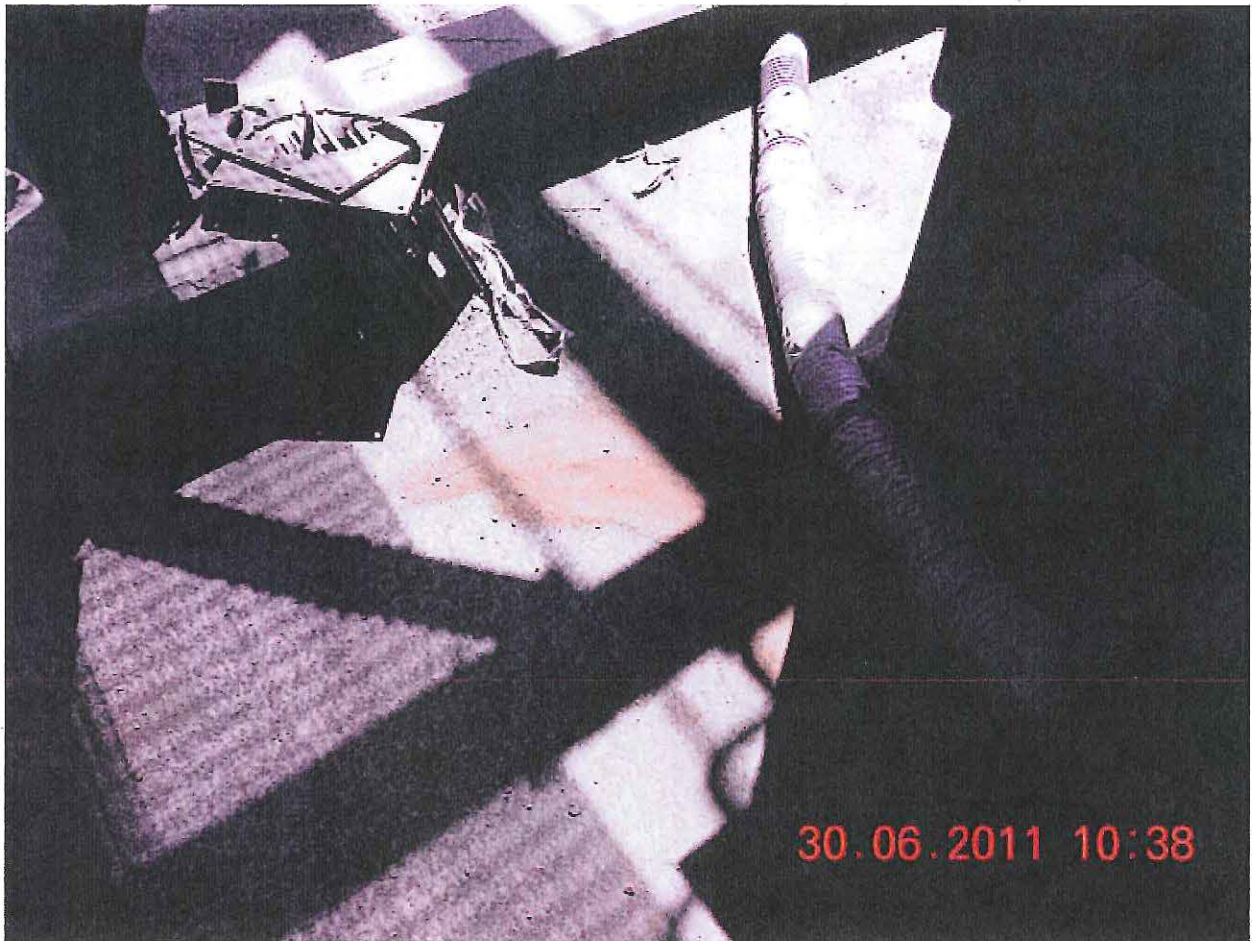
Facility: Arcelor Mittal, IND003913423
Location: 250 West US Highway 12, Burns Harbor, Indiana
Date: June 30, 2011, 10:38 a.m.
Photographer: Robert Dean Smith, LPG
Camera: Nikon Coolpix, 12.0 megapixels
Description: Photograph 89: Dust in secondary containment located under the dust box labeled "Module #5".

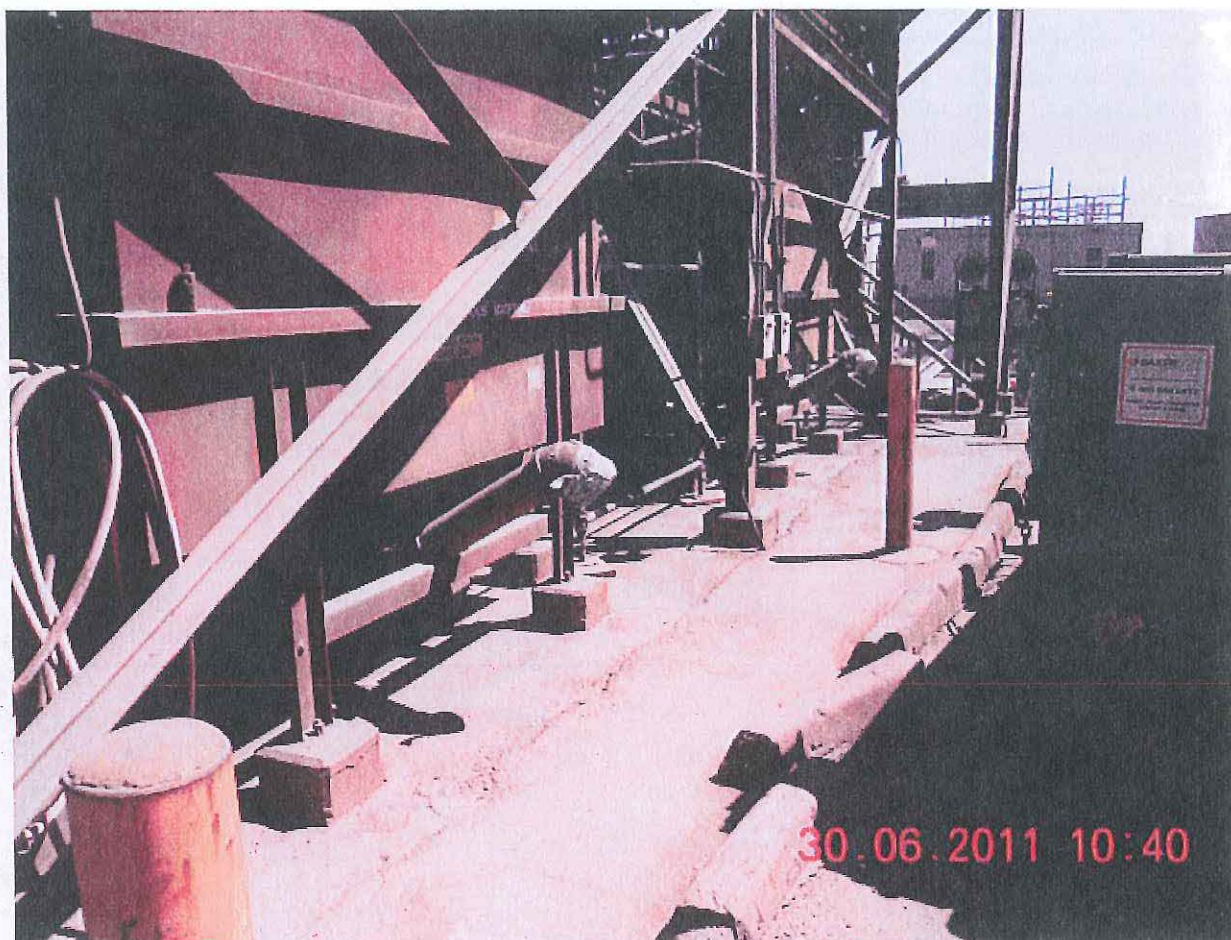
- Inspector Smith observed and photographed dust boxes 3 and 4 (photograph 90).
- Inspector Smith observed and photographed dust boxes 1 and 3. While the ground or concrete below the boxes seem to be reddish or reddish brown, there was no visible dust on the ground. The dust boxes are reddish brown in color (photograph 91).

Facility: Arcelor Mittal, IND003913423
Location: 250 West US Highway 12, Burns Harbor, Indiana
Date: June 30, 2011, 10:40 a.m.
Photographer: Robert Dean Smith, LPG
Camera: Nikon Coolpix, 12.0 megapixels
Description: Photograph 90: Dust box 3 and 4. Facing N.

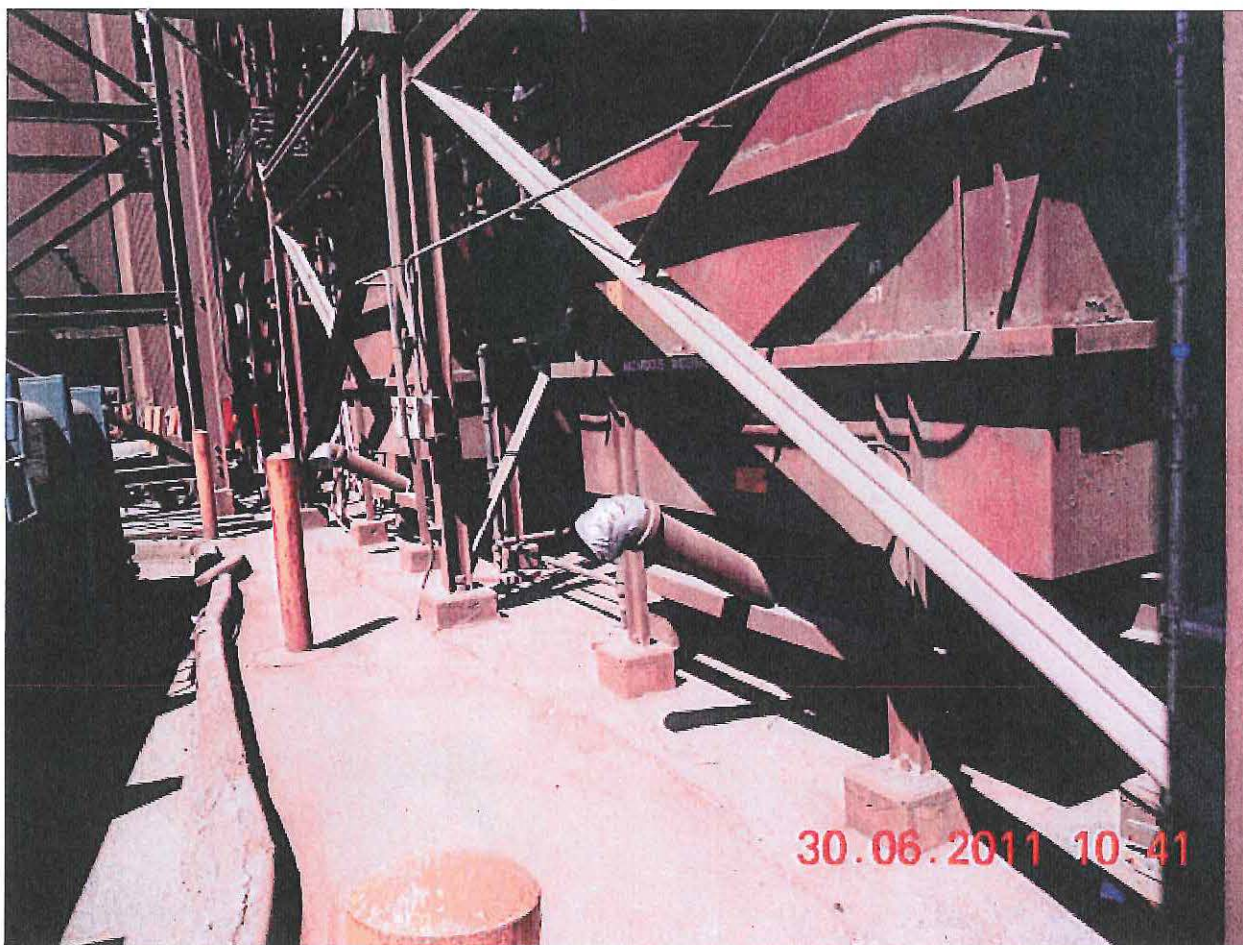
Facility: Arcelor Mittal, IND003913423
Location: 250 West US Highway 12, Burns Harbor, Indiana
Date: June 30, 2011, 10:41 a.m.
Photographer: Robert Dean Smith, LPG
Camera: Nikon Coolpix, 12.0 megapixels
Description: Photograph 91: Dust boxes 1 & 2. Facing S.

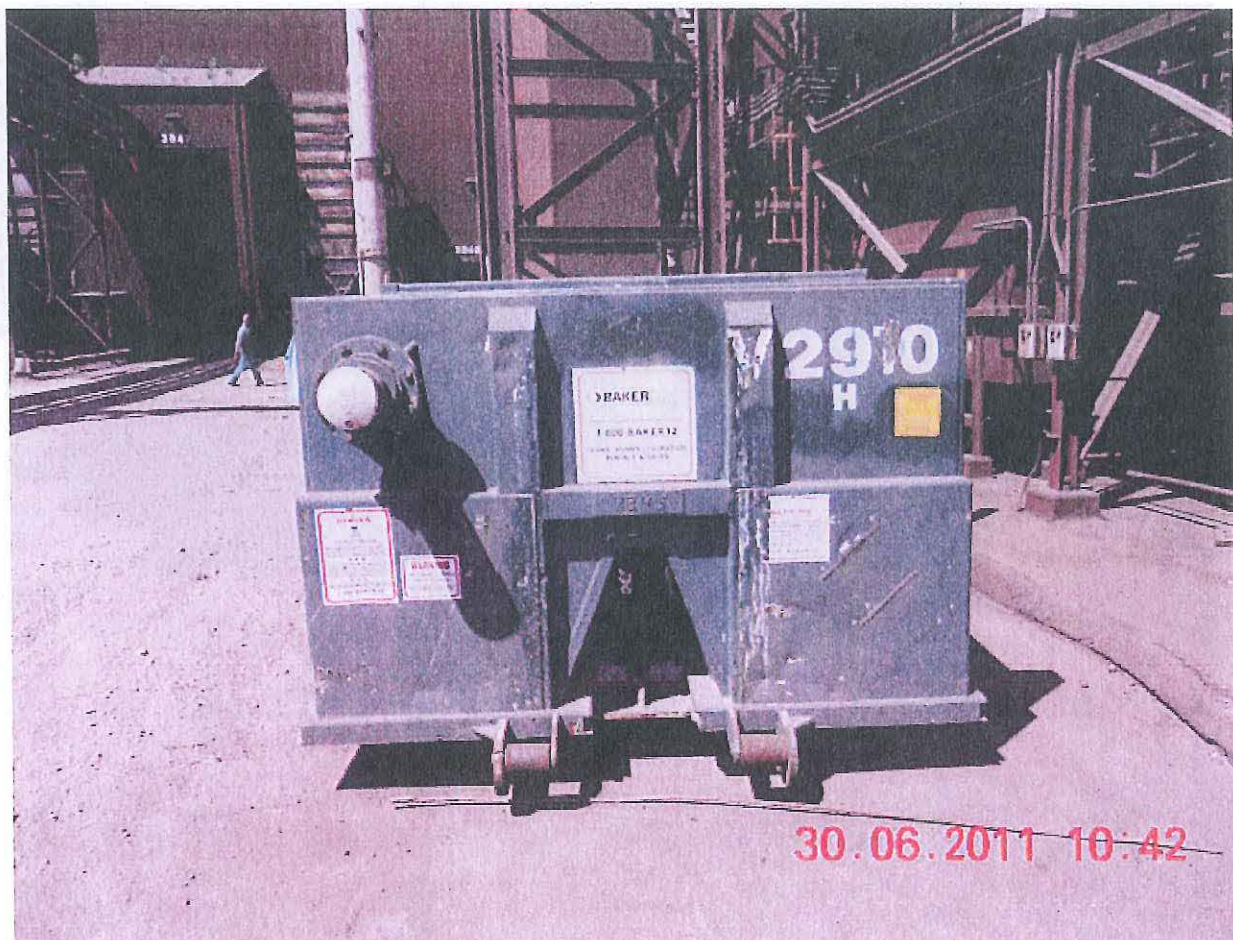
- Inspector Smith observed and photographed roll-off box V2910 and determined that no hazardous waste dust was released from the roll-off box (photograph 92).

Facility: Arcelor Mittal, IND003913423
Location: 250 West US Highway 12, Burns Harbor, Indiana
Date: June 30, 2011, 10:43 a.m.
Photographer: Robert Dean Smith, LPG
Camera: Nikon Coolpix, 12.0 megapixels
Description: Photograph 92: Vacuum roll off box number V2910. The roll off box is marked and labeled. There is no sign of leakage from this roll off box. This vacuum roll-off box is located in the furnace area of the plant. This area is 30 degrees off of "plant north". The orientation is rotated 30 degrees to the west. Plant north is close to true north . The orientation of the vacuum roll-off box is close to NE-SW. Facing SW.

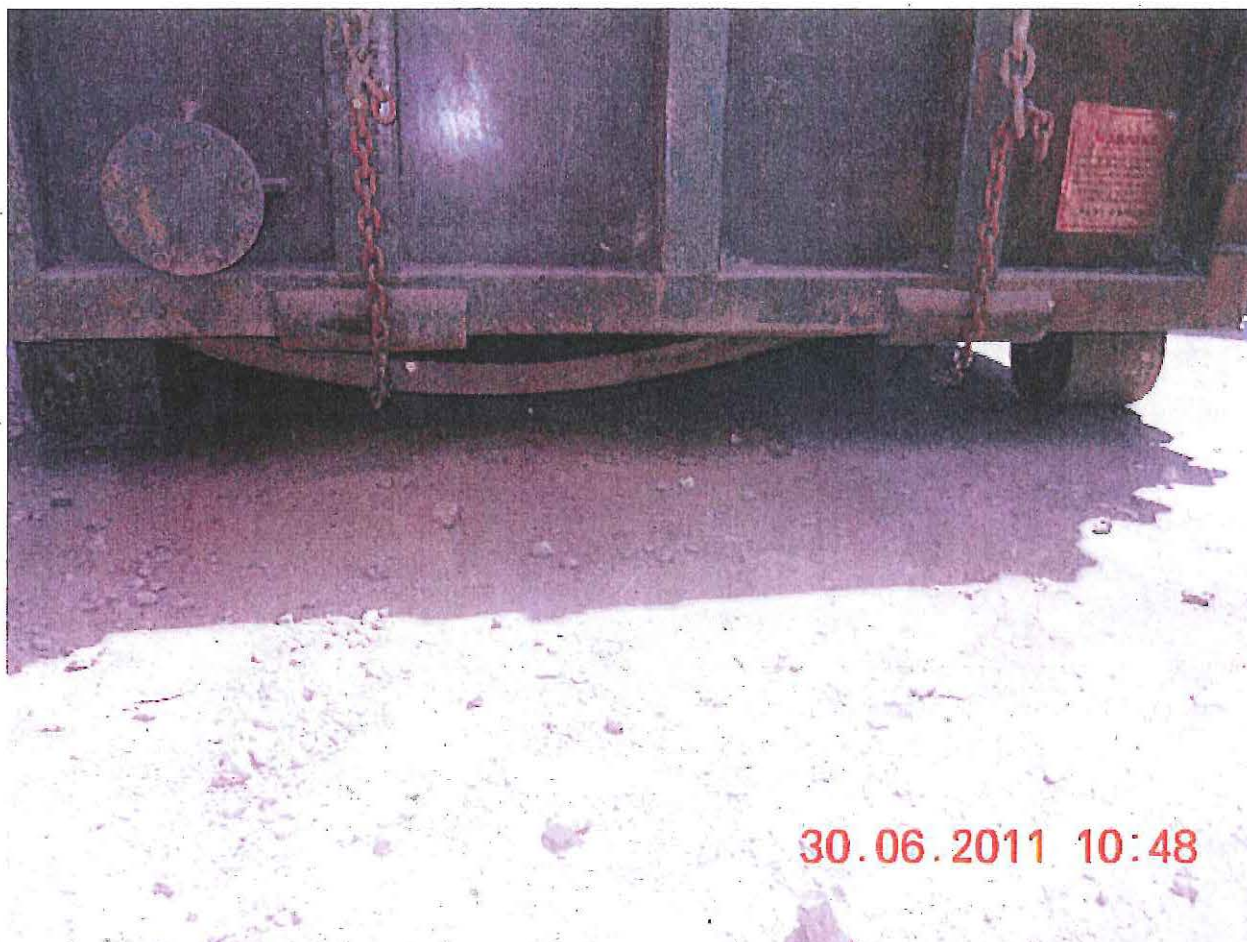
- Inspector Smith observed and photographed that an employee from AM had removed much of the suspected hazardous waste dust as he collected samples for analysis. The photograph clearly shows the blown gasket (Photograph 93).
- Inspector Smith observed and photographed the hazardous waste sticker on the roll-off box that released the suspected hazardous waste dust (photograph 94).
- Inspector Smith observed and photographed the opposite end of the roll off box with the serial number V24283 that released the potential hazardous waste dust. The roll off box had a hazardous waste sticker that was photographed in photograph 94 (photograph 95).

Facility: Arcelor Mittal, IND003913423
Location: 250 West US Highway 12, Burns Harbor, Indiana
Date: June 30, 2011, 10:48 a.m.
Photographer: Robert Dean Smith, LPG
Camera: Nikon Coolpix, 12.0 megapixels
Description: Photograph 93: Close up of blown gasket on roll off box V24283. Arcelor Mittal had already taken a sample of the released dust which is evident by the absence of the small pile of released dust. A small amount of dust remains on the ground. This vacuum roll-off box is located in the furnace area of the plant. This area is 30 degrees off of "plant north". The orientation is rotated 30 degrees to the west. Plant north is close to true north. The orientation of the vacuum roll-off box is close to NE-SW. Facing NE.

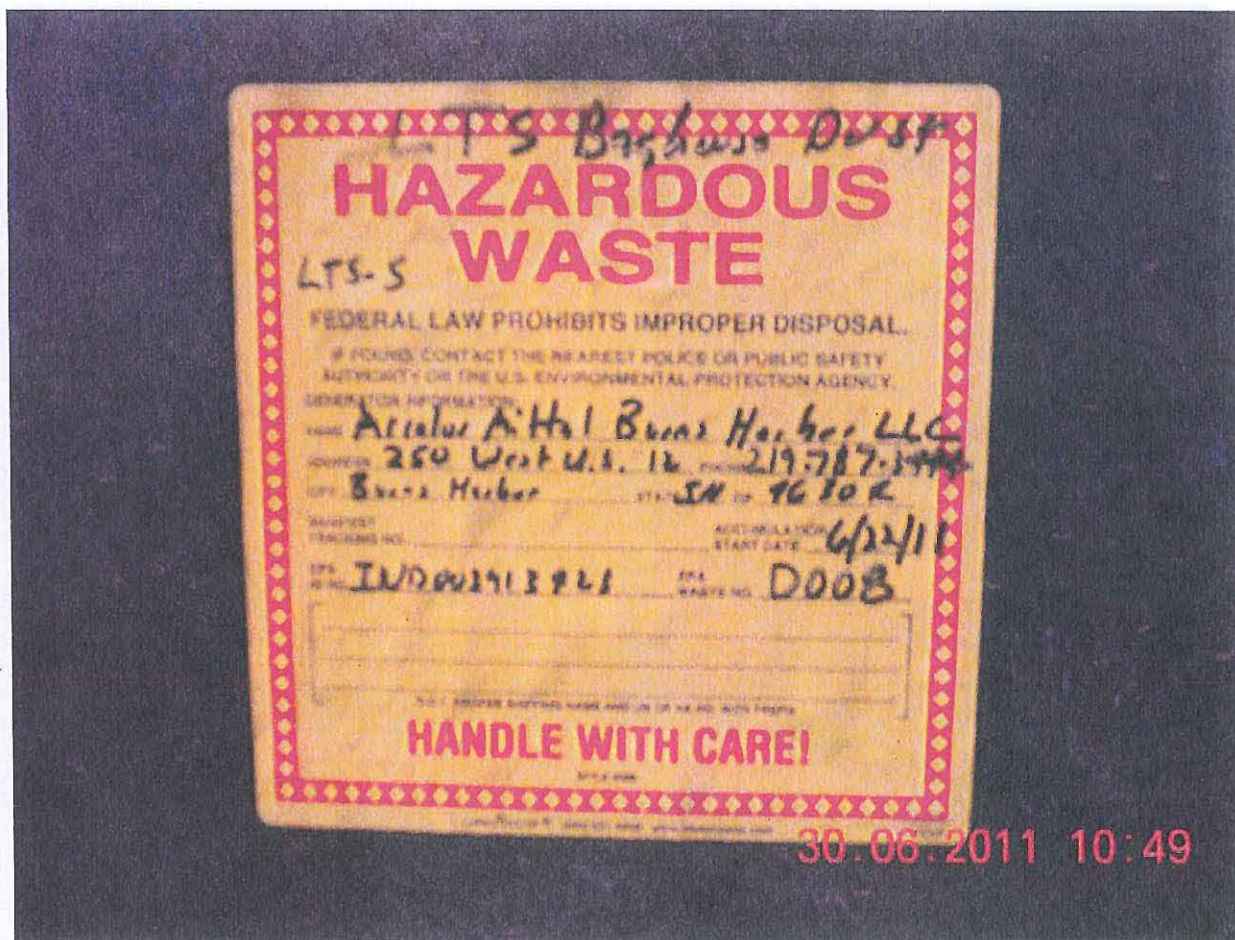
Facility: Arcelor Mittal, IND003913423
Location: 250 West US Highway 12, Burns Harbor, Indiana
Date: June 30, 2011, 10:49 a.m.
Photographer: Robert Dean Smith, LPG
Camera: Nikon Coolpix, 12.0 megapixels
Description: Photograph 94: Label on vacuum roll off box V24283. The label states that the contents of the roll off box is LTS baghouse dust and has the hazardous characteristic code of D008.
